Cylinders troubleshooting

The following sections provide guidelines for the common cylinders failures with a simple scheme driving through the analysis of causes and preventive actions to avoid premature breakdowns. The last section gives useful information about the main spare parts codes necessary to proceed with a complete cylinder's mechanical overhaul.

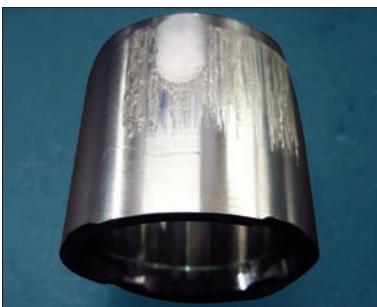
2 FLUID CONTAMINANTS

Trouble description: contaminated fluid is one of the main causes of seal leakages. Abrasive particle contamination is evidenced by scratch and score marks on the seals, rod bearing and cushioning piston with consequent leakages and loss of cushioning effect which place the cylinder out of service.

Action & prevention: hydraulic circuit must be provided with appropriate filters (at least 25 µm) to grant a contamination class lower than ISO 19/18/15 according to ISO 4406. Take care to grant adequate recirculation of the oil flow.

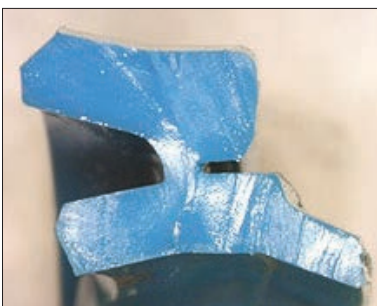
3 OVERPRESSURE

Trouble description: excessive flow restriction in the hydraulic circuit or mechanical rod shocks could involve peaks of pressure which stress rod seals and give rise to rapid seal wear and leakages. The seals appears with abnormal wear and, in the worst cases, extruded.

Action & prevention: hydraulic circuit must be designed to avoid flow restrictions which could involve dangerous peaks of pressure. A PTFE sealing system **G2-G4-G8** should be preferred if the peaks of pressure cannot be reduced, contact Atos technical office.

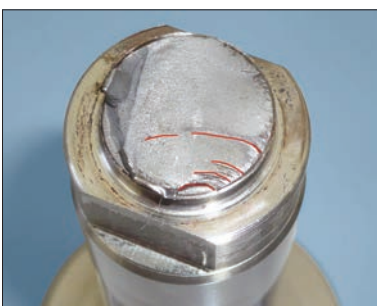
8 HIGH PRESSURE / LOADS

Trouble description: overpressures/overloads respect to cylinders limits or high loads/pressures coupled to high frequency applications or long life expectations may involve mechanical failures of the rod thread, that is the most critical part of any hydraulic cylinder. In the first case a ductile failure may result, the rod end presents a necking area followed by a tear break zone; in the second one a fatigue failure may occur, the breaking of the rod thread is featured by an early progression of serious brittle cracks (see red line in the picture) with final plastic yielding.

Action & prevention: in case of ductile failure check the compliance of actual pressures/loads with the cylinder's max operating pressure shown in relevant technical table. In case of fatigue failure check the fatigue life expectation in accordance with the instructions given in tech. table **B015**. If above checks highlight conforming application data please contact Atos technical office.
